TENNESSEE VALLEY AUTHORITY
WATER CONTROL PLANNING DEPARTMENT

REPORT NO. O-3075

FLOOD CONTROL
FOR
UPPER FRENCH BROAD RIVER
AND
TRIBUTARIES

A PRELIMINARY REPORT

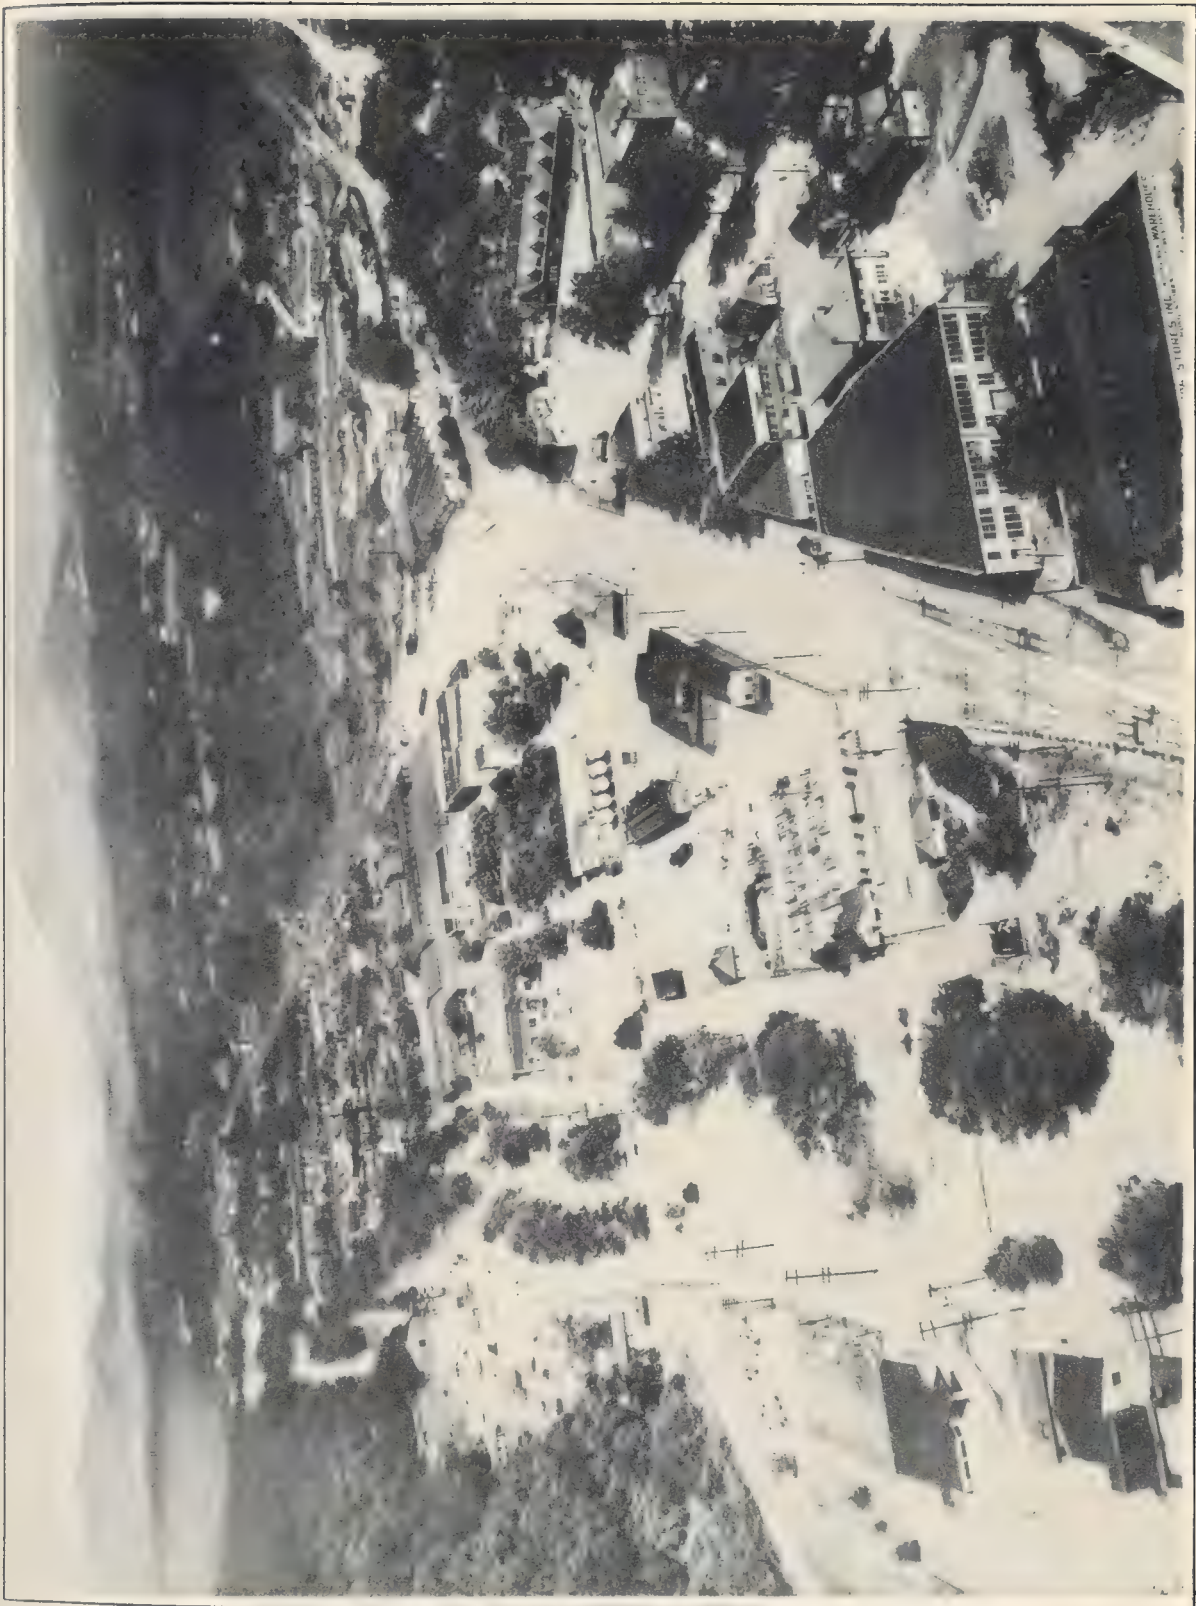
FIGURE 1 — BILTMORE SECTION OF ASHEVILLE FLOODED BY SWANNANOA RIVER AUGUST 30, 1940
*Flood of August 13 was 3 feet higher causing large losses to industries and commercial concerns.
Flood of July 1916 was 6 feet higher than that of August 30, 1940. (Asheville Citizen-Times photo)*

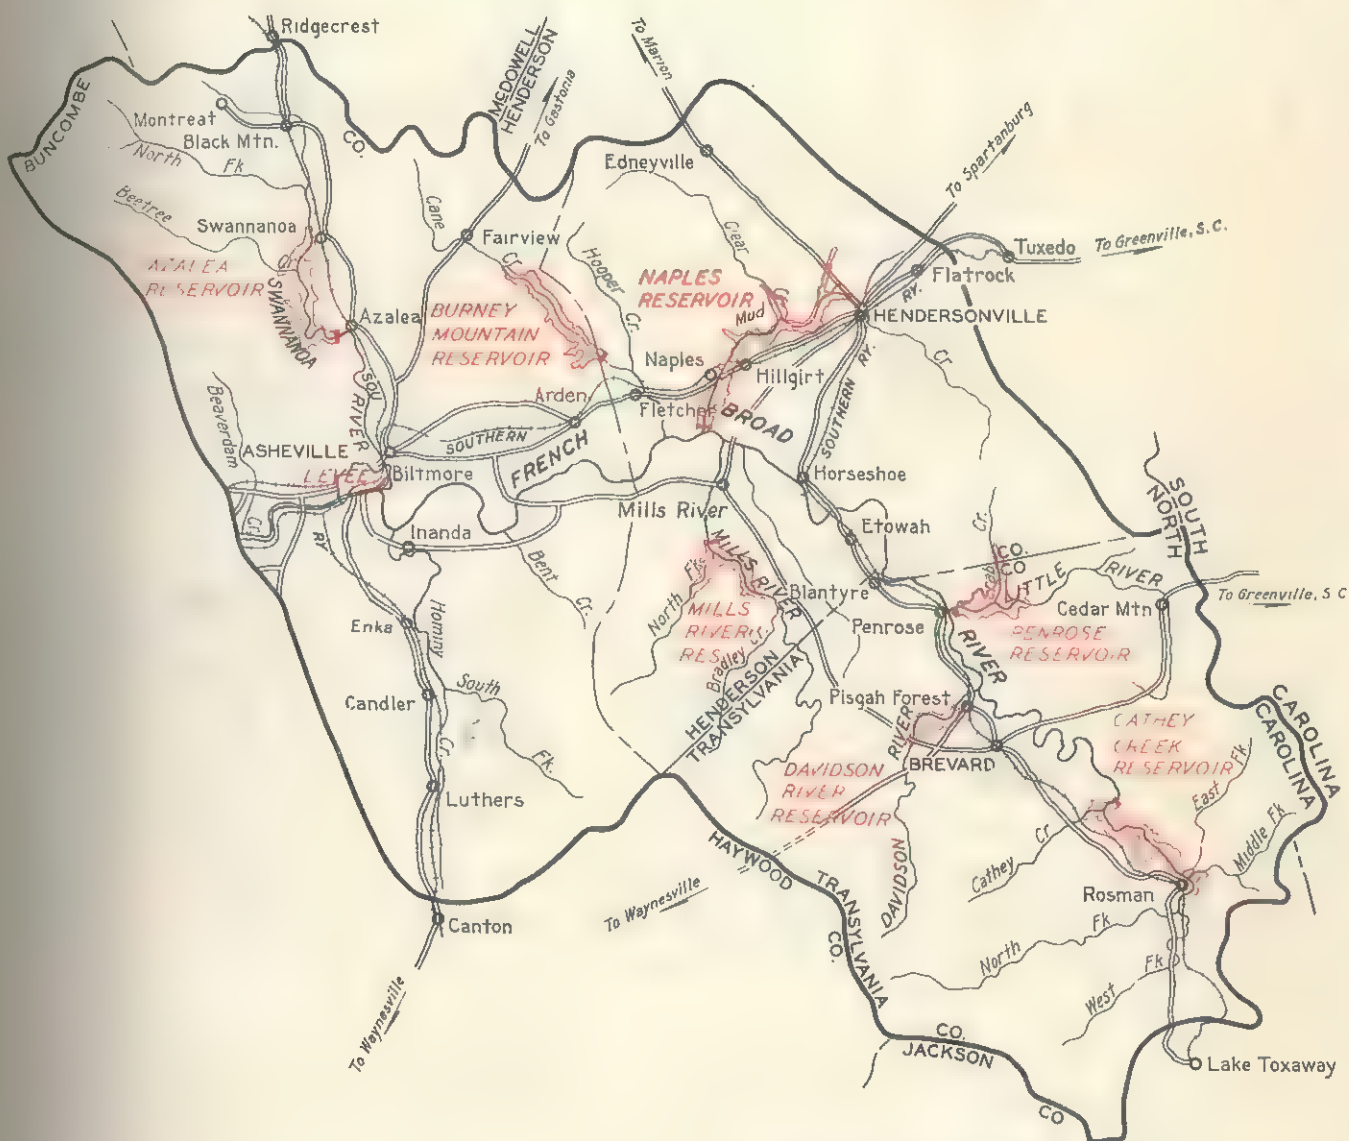
PROPOSED
REGIONAL PLAN FOR FLOOD CONTROL
UPPER FRENCH BROAD RIVER BASIN

To provide flood control for both urban and rural areas on a regional basis, including the city of Asheville and the Upper French Broad valley, a plan has been developed, the principal features of which are shown on plate 4. This includes seven storage reservoirs of the detention basin type, a levee at Asheville, and some minor channel improvements on the Swannanoa and French Broad Rivers. Table 1 gives pertinent data regarding the reservoirs. The plan provides complete protection for Asheville and agricultural protection as previously defined for the valley lands.

The storage capacity of each reservoir has been planned consistent with the degree of flood protection desired from each reservoir. The Azalea Reservoir on the Swannanoa River is designed with a storage capacity at the level of the spillway of 12 inches of runoff from the tributary drainage area in order that the valuable industrial and commercial district in Biltmore would never be damaged by Swannanoa River floods. The storage reservoirs on

Considering the Upper French Broad region above Asheville, including the city and the agricultural valley lands, a plan has been worked out to provide flood protection. This includes seven storage reservoirs of the detention basin type at the locations shown on plate 4 and a levee along the French Broad River at Asheville. The Azalea Reservoir on Swannanoa River which is essential for the protection of the industrial area along the river through the Biltmore section of Asheville is of sufficiently large capacity to control all floods on that river. The other reservoirs are designed to provide agricultural flood protection and about once in twelve years on the average some flooding of the valley lands may be expected. All of the reservoirs are detention basins which hold water only a few days after a flood and thus permit the use of the lands within the reservoirs for general farming purposes as in the past. The cost of this plan is estimated at \$8,210,000. The estimated tangible benefits from flood protection under the plan are \$9,000,000. In addition, there are intangible benefits which although real are difficult to evaluate.

This plan shown on plate 4 has been previously described. It includes principally seven storage reservoirs and a levee along the Asheville water front of the French Broad River. The reservoirs included in this plan are each described under the respective sections of this report which relate to the particular streams on which they are located.

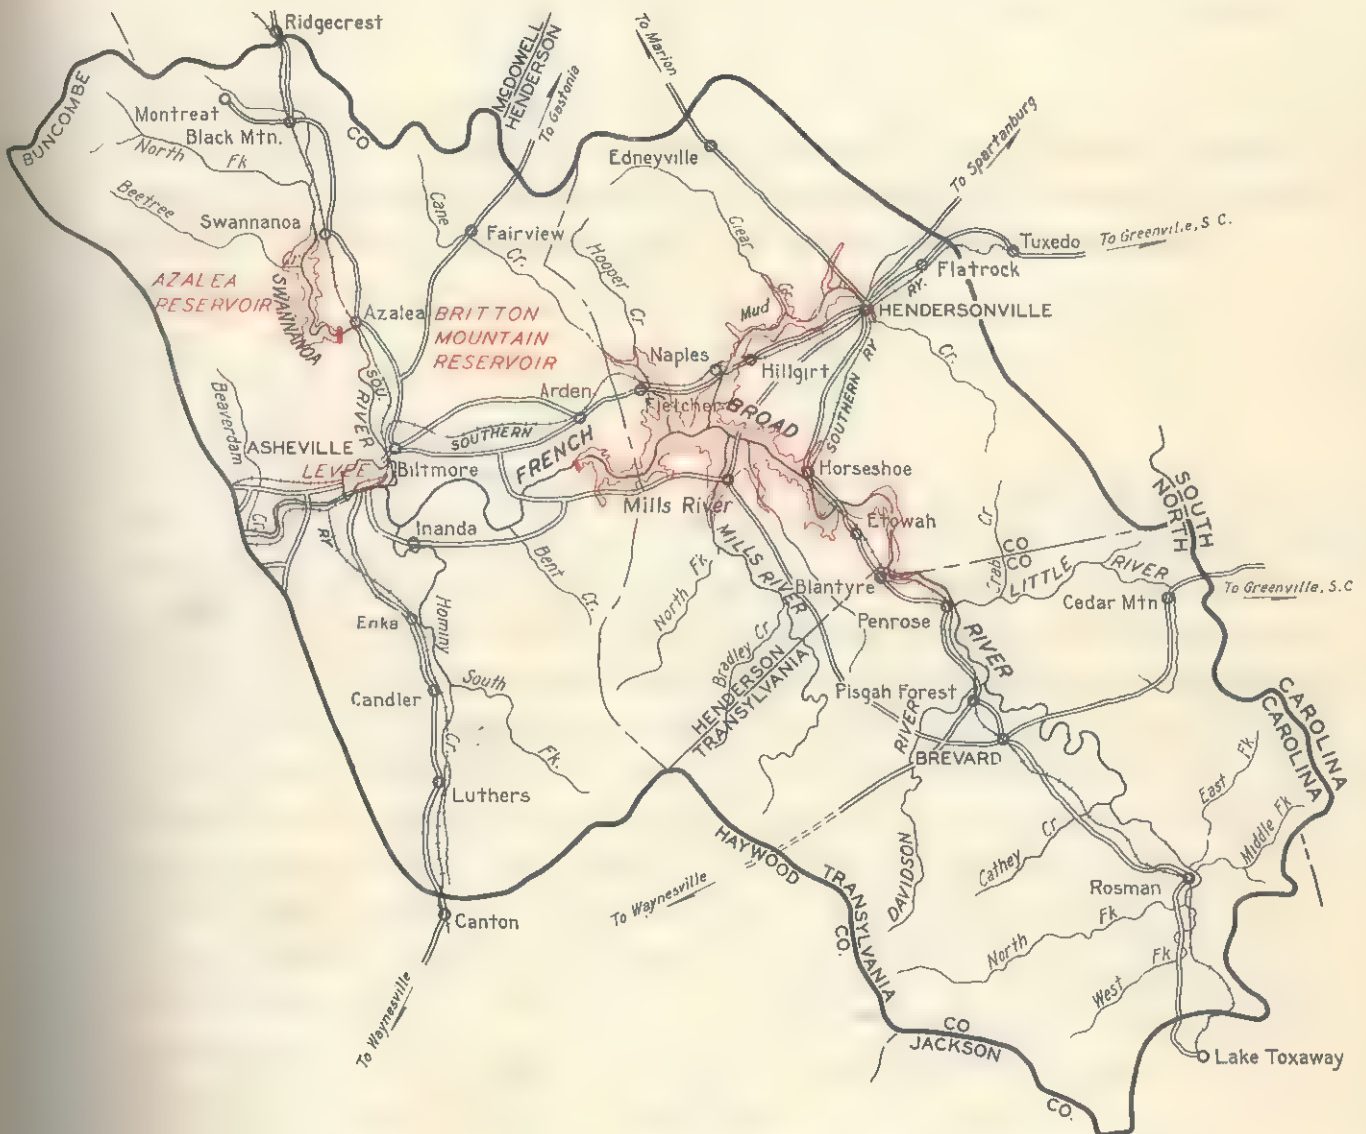
PROPOSED
FLOOD CONTROL PLAN FOR ASHEVILLE ONLY
UPPER FRENCH BROAD RIVER BASIN

To provide flood control for the industrial and commercial areas in Asheville including those in Biltmore on the Swannanoa River but not protecting any of the agricultural valley lands, the plan shown on plate 5 has been prepared. This includes two storage reservoirs of the detention basin type, a levee through Asheville and the improvement of the Swannanoa River channel. Table 1 gives pertinent data regarding the reservoirs.

The Azalea Reservoir on the Swannanoa River under this plan would be the same as that under the Regional Plan because this is necessary to completely protect Biltmore from Swannanoa River floods. The second storage reservoir is located on the main French Broad River twelve miles upstream from Asheville at the Britton Mountain site. For a single reservoir to control French Broad floods originating upstream from the mouth of the Swannanoa River, this reservoir should be located immediately upstream from Asheville, in order that the reservoir may catch the flood runoff from any part of the 650 square miles of upstream drainage area and control this regardless of its origin. Storage capacity at the elevation of the spillway amounting to 6 inches from the upper watershed has been planned for this reservoir. Through the dam are uncontrolled outlet conduits purposely

An alternate plan has been developed for the protection of the industrial and commercial areas along the French Broad River and the Swannanoa River in Asheville, leaving out the protection of the agricultural valley lands upstream. This is shown on plate 5. The cost of this plan is estimated at \$4,803,000. The estimated tangible benefits principally to the

This plan, shown on plate 5 and previously described, includes the Azalea Reservoir on Swannanoa River, Britton Mountain Reservoir on the French

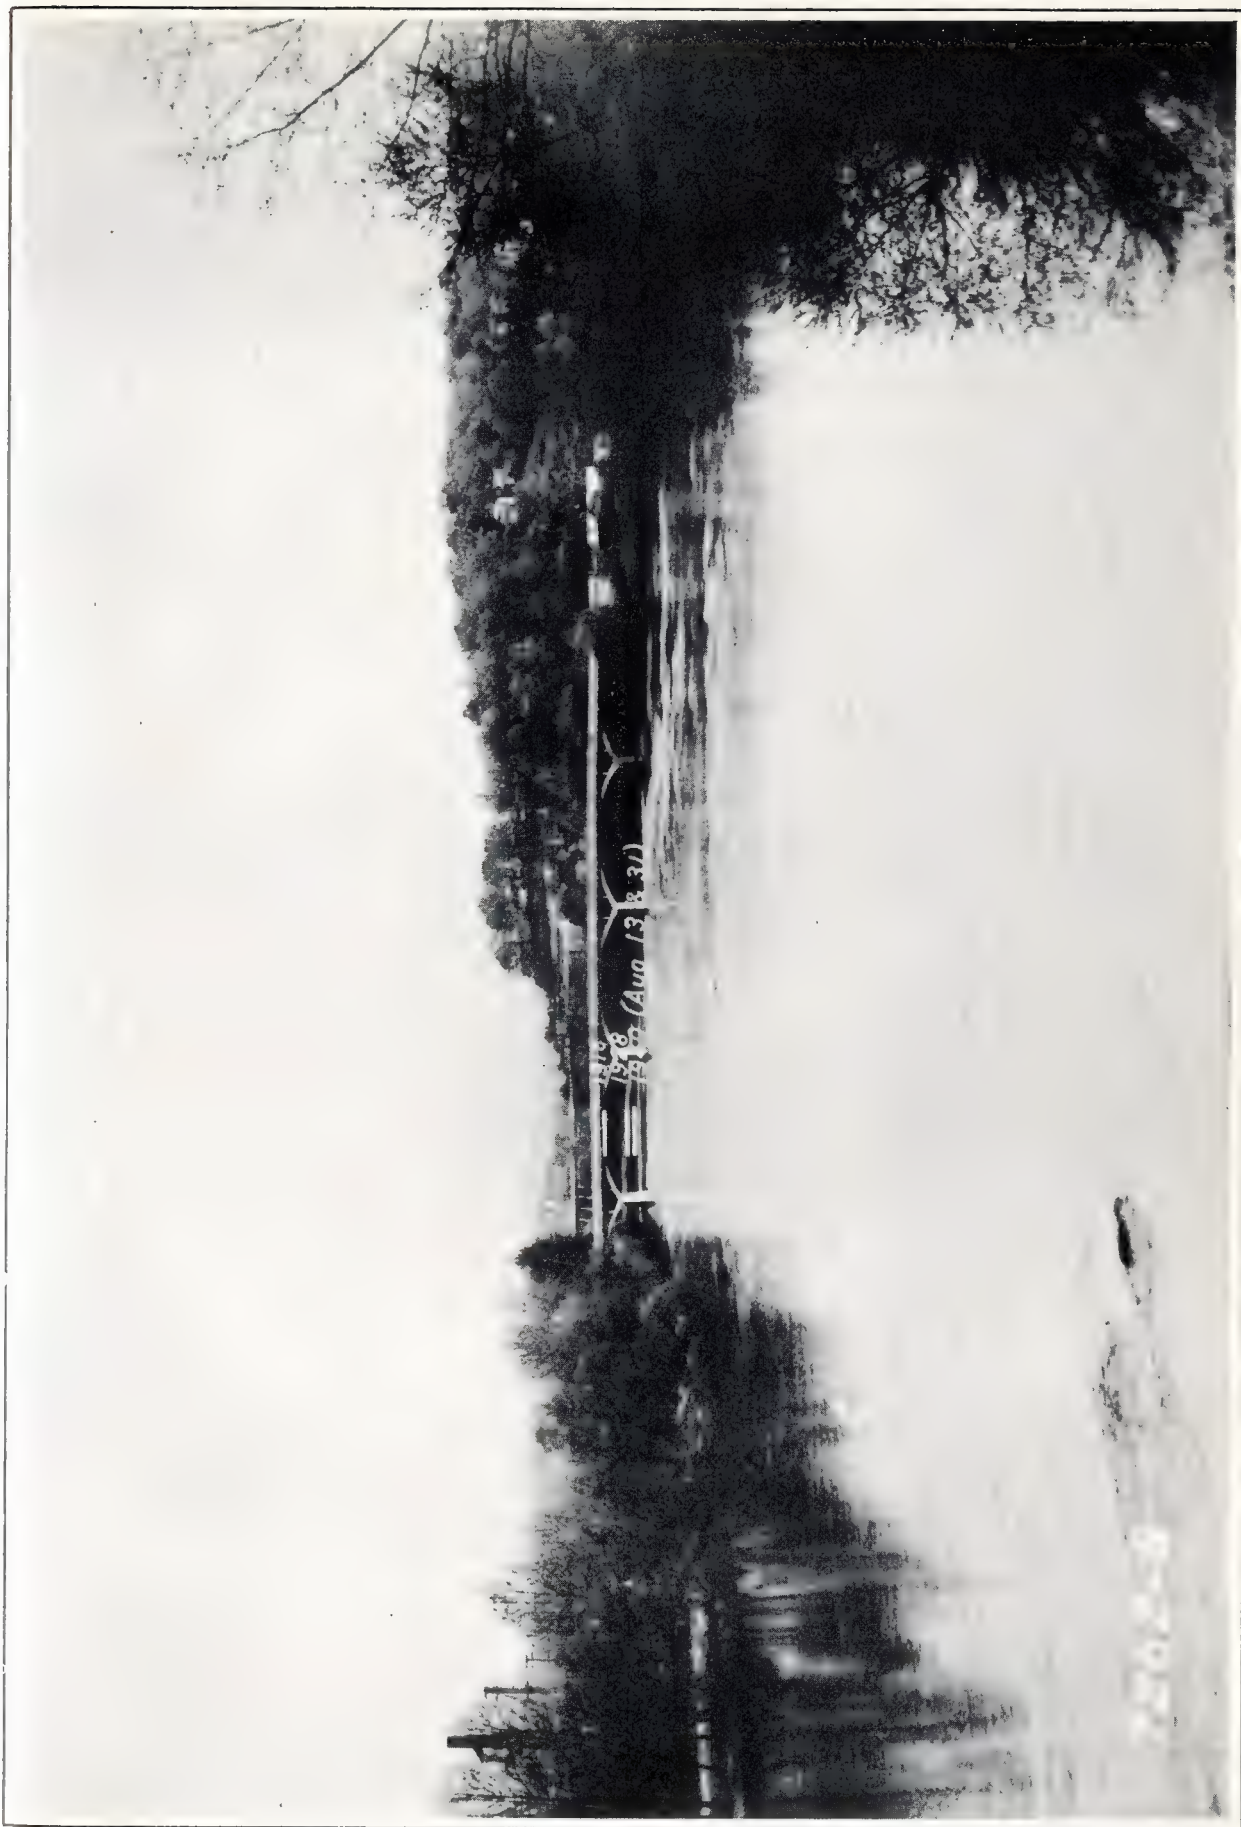
FIGURE 3 — SMITH BRIDGE, FRENCH BROAD RIVER AT ASHEVILLE

A steel bridge at this site was carried away by the 1916 flood. This flood would reach approximately to the crown of the arches of the center spans on the present bridge. The side arches which are lower than the center arches would obstruct maximum flood flows.

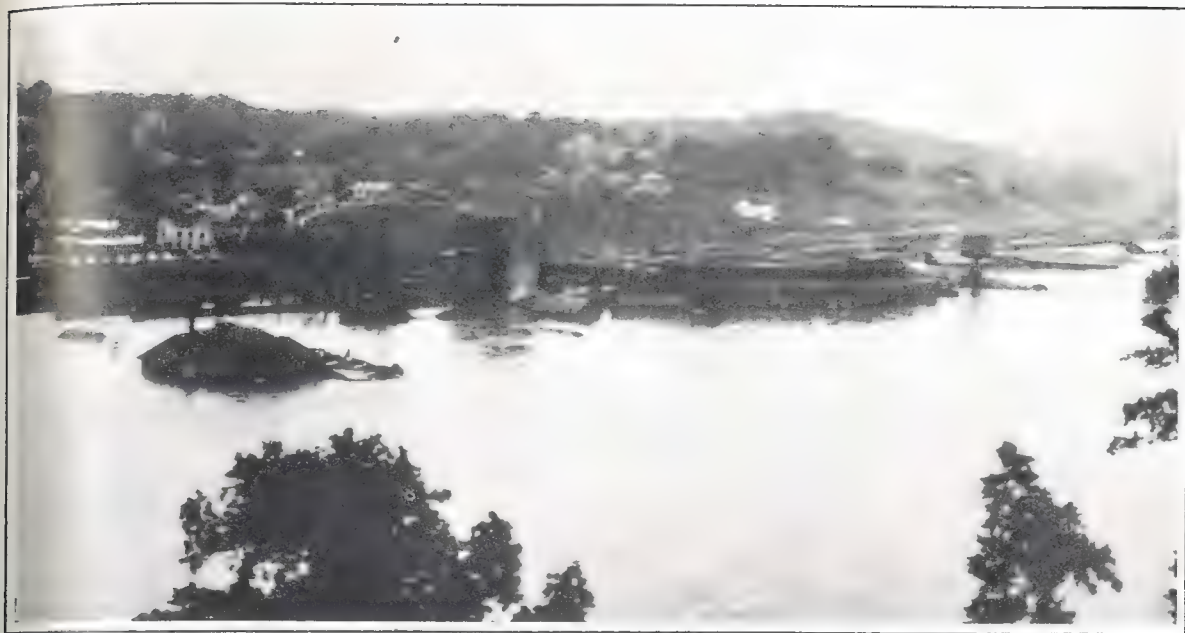
FIGURE 5 — SOUTHERN RAILWAY CRIPPLED BY FLOOD IN 1916

The large yards and roundhouse of the Southern Railway were flooded. Building in foreground is foundry of Carolina Machinery Company. White building in left background is passenger depot. (Southern Railway photo)

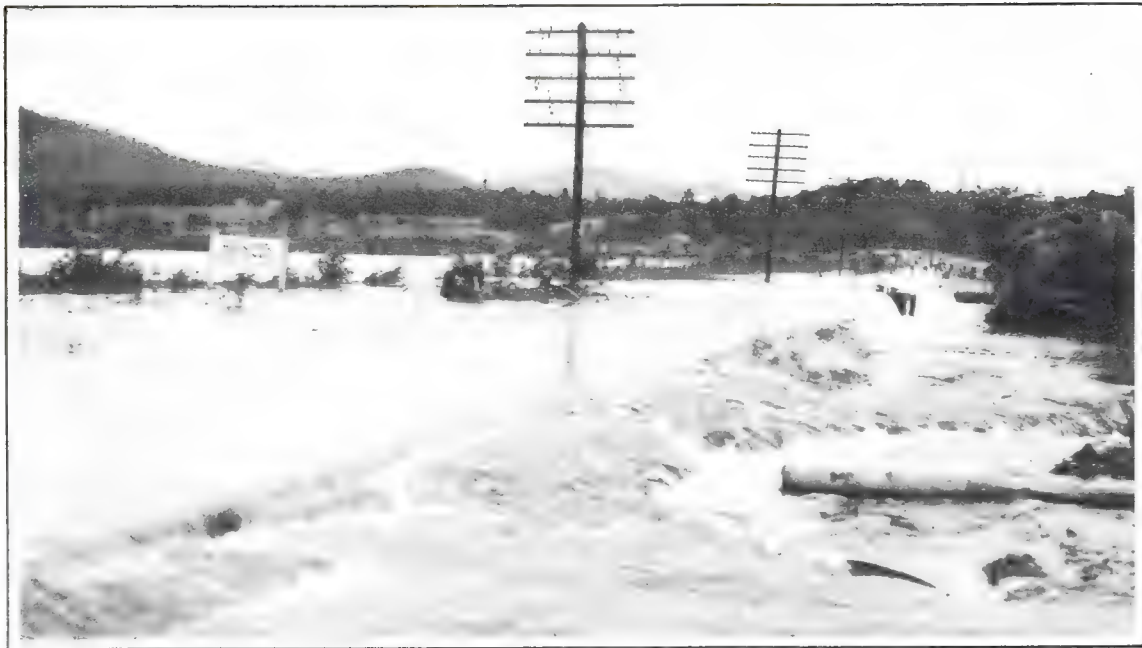
FIGURE 7 — U. S. HIGHWAY 70 OVERFLOWED BY SWANNANOA RIVER AUGUST 13, 1940
700 feet of the highway were overflowed and washed out by undercutting.

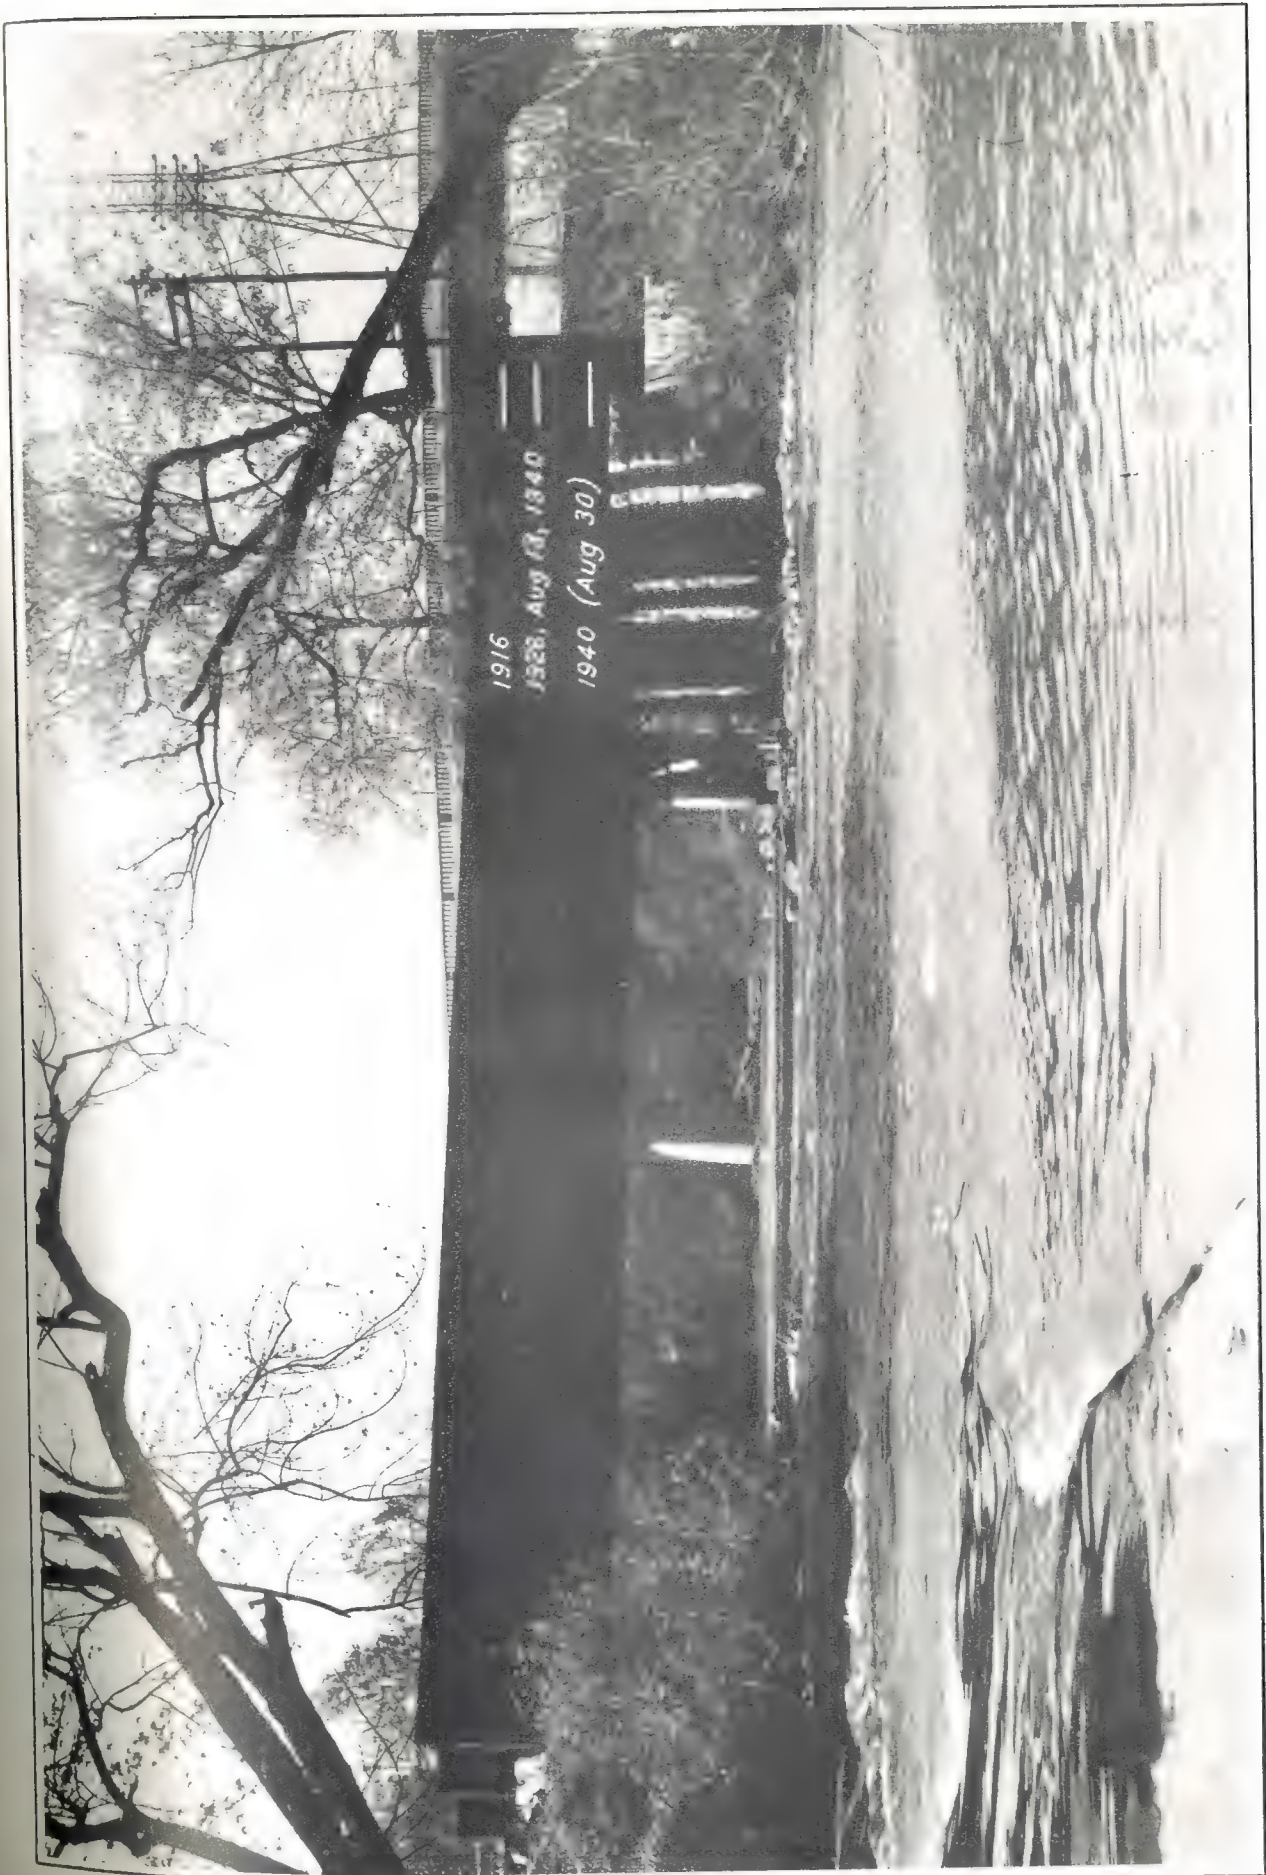
FIGURE 9 — SOUTHERN RAILWAY BRIDGE ACROSS SWANNANOA RIVER IN BILTMORE
This is one of 12 bridges below the proposed Azalea Dam site, nearly all of which offer serious obstruction to large floods.

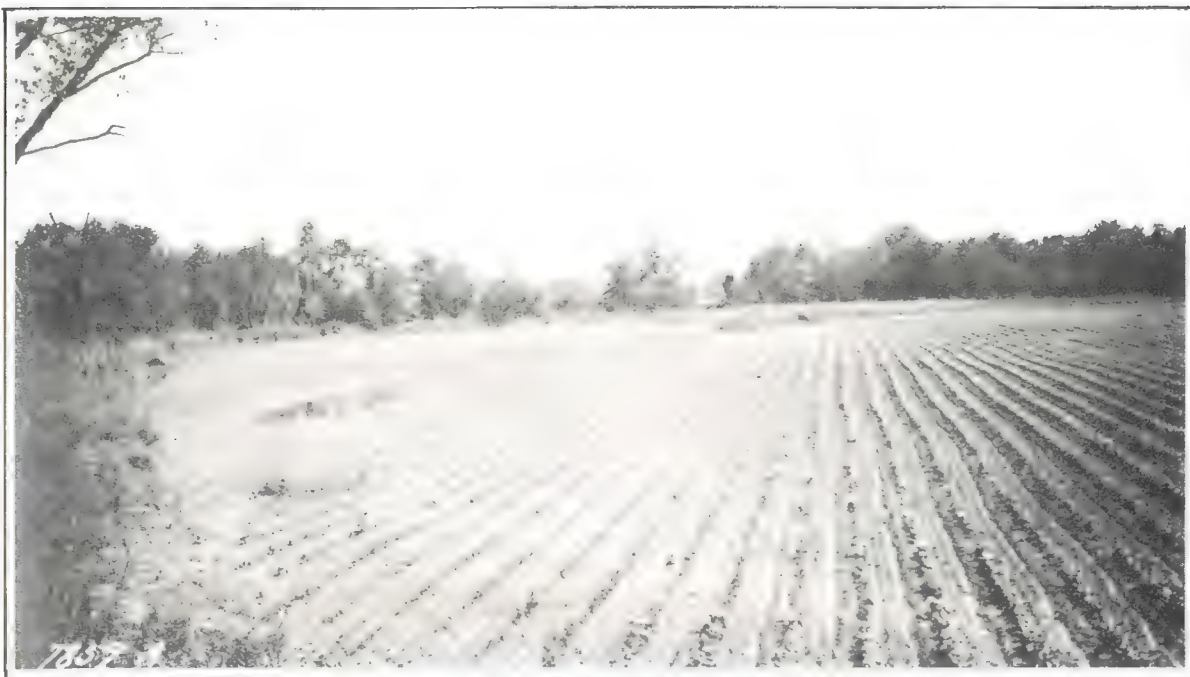
FIGURE 10 — GREEN BEAN FIELD FLOODED AUGUST 17, 1939

This field of green beans in the valley of the French Broad River near Butler Bridge was a complete loss after being flooded. Truck crop losses in the August 1940 floods ranged from \$100 to more than \$300 per acre.

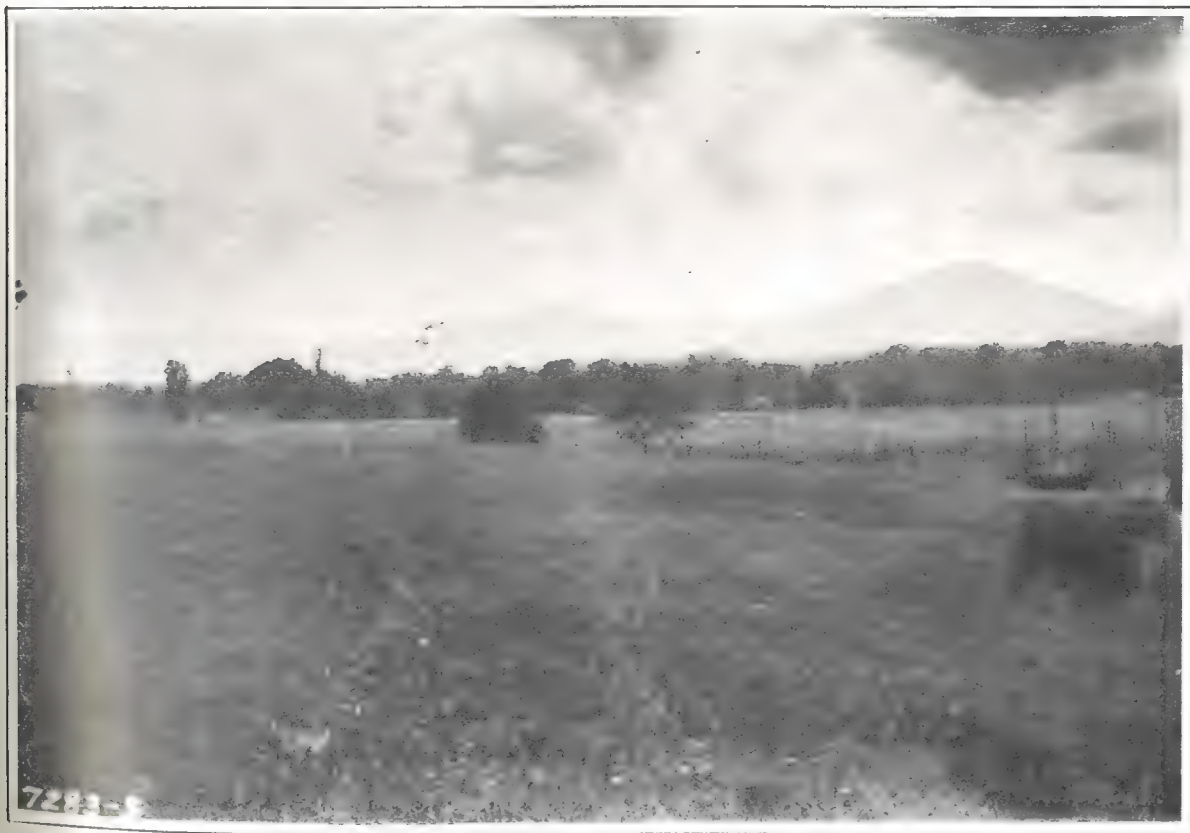
FIGURE 11 — BOTTOM LANDS ALONG LOWER REACH OF CANE CREEK

The bottoms along this reach are about a half mile wide and are overflowed whenever Cane Creek is in flood. The creek follows the thin line of trees in the middle background.

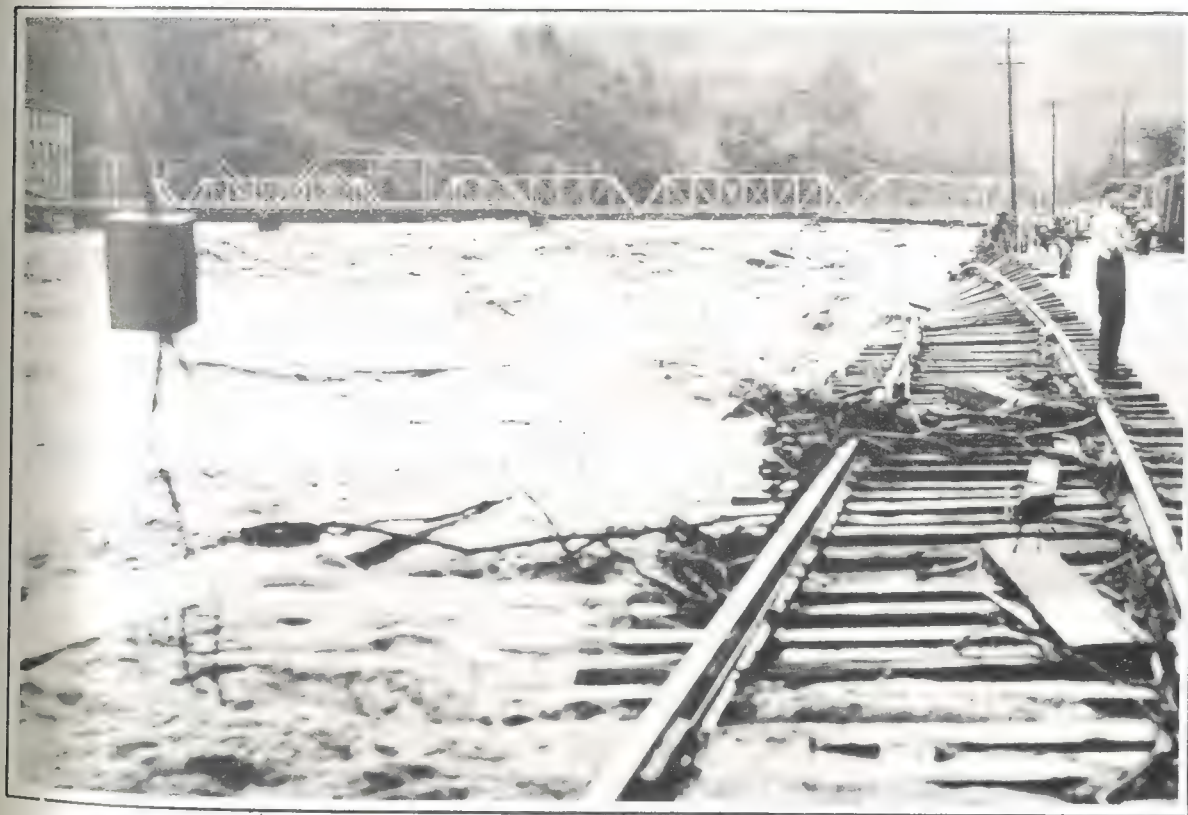
FIGURE 16 — SOUTHERN RAILWAY TRACKS BADLY WASHED AUGUST 1940 AT MARSHALL
Over 1000 feet of track were carried into the river at this location. The Southern Railway station was also partially destroyed by the flood. One span of the upper river bridge shown in the background was washed out by the flood.

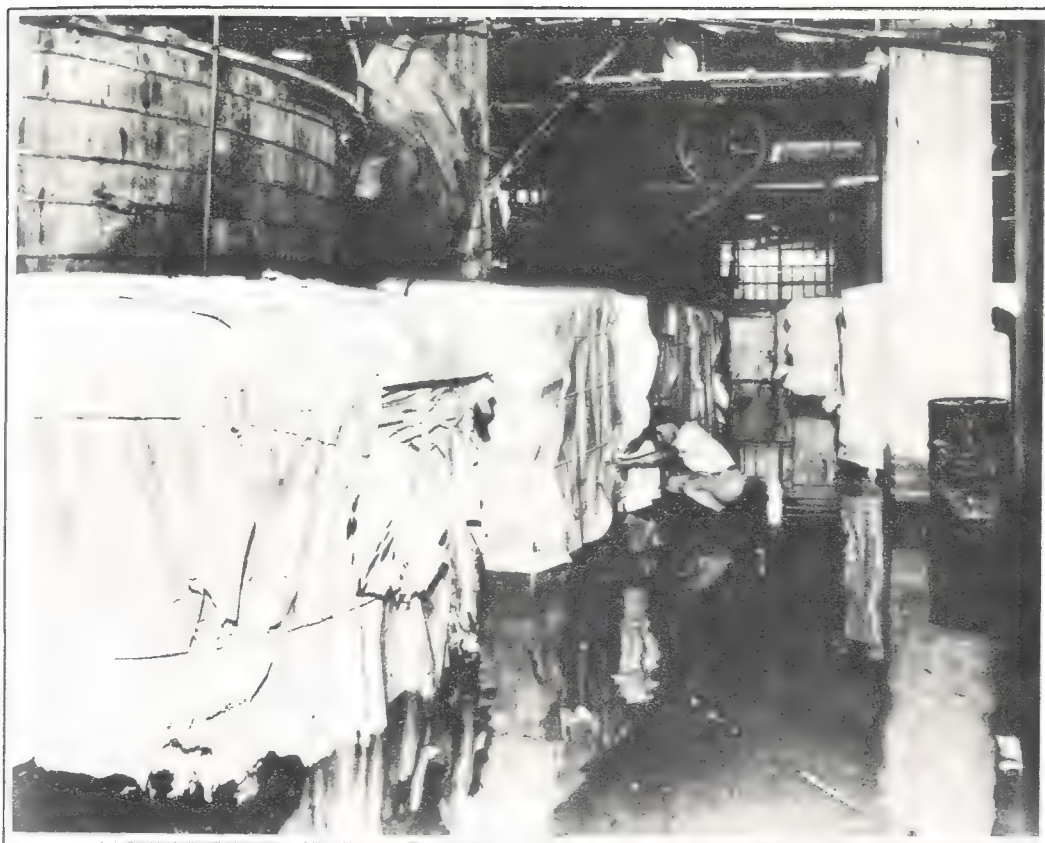
FIGURE 17 — AFTER THE MID-AUGUST 1940 FLOOD ON PIGEON RIVER
Inside the plant of the Champion Paper and Fibre Company at Canton. The late August flood was about 3 feet higher than the flood line shown in the picture. (Asheville Citizen-Times photo)

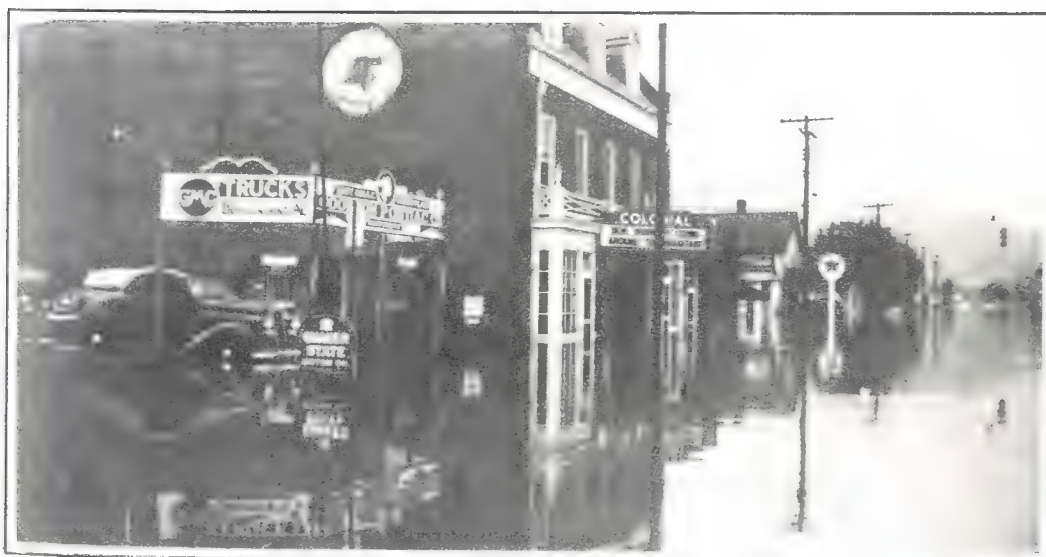
FIGURE 18 — CANTON STREET FLOODED AUGUST 30, 1940
On Park Street, Canton, North Carolina, business and commercial establishments were flooded by the late August 1940 flood.

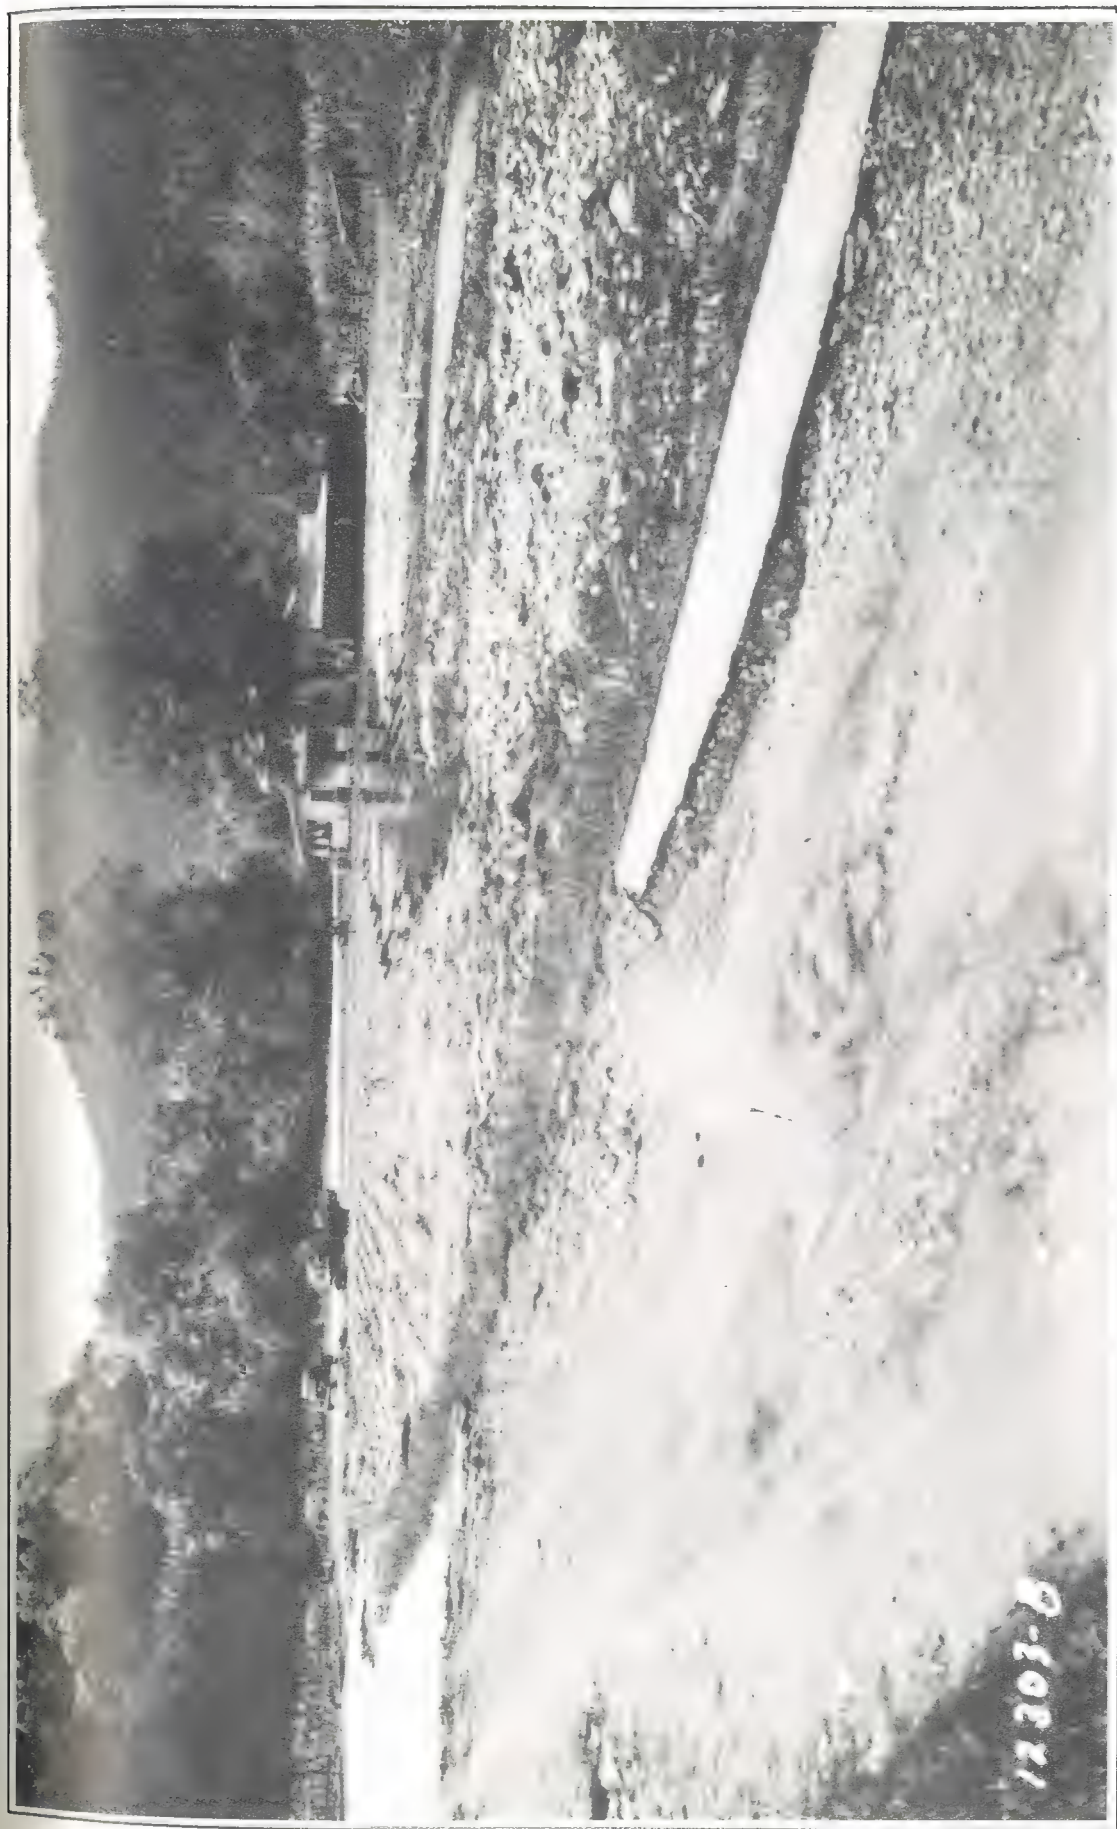
FIGURE 19 -- FARM LAND ON EAST FORK OF PIGEON RIVER DAMAGED AUGUST 13, 1940
*Flood waters destroyed crops, scoured some land and deposited boulders on other land causing serious damages.
The black top roadway was also washed away by the flood waters.*

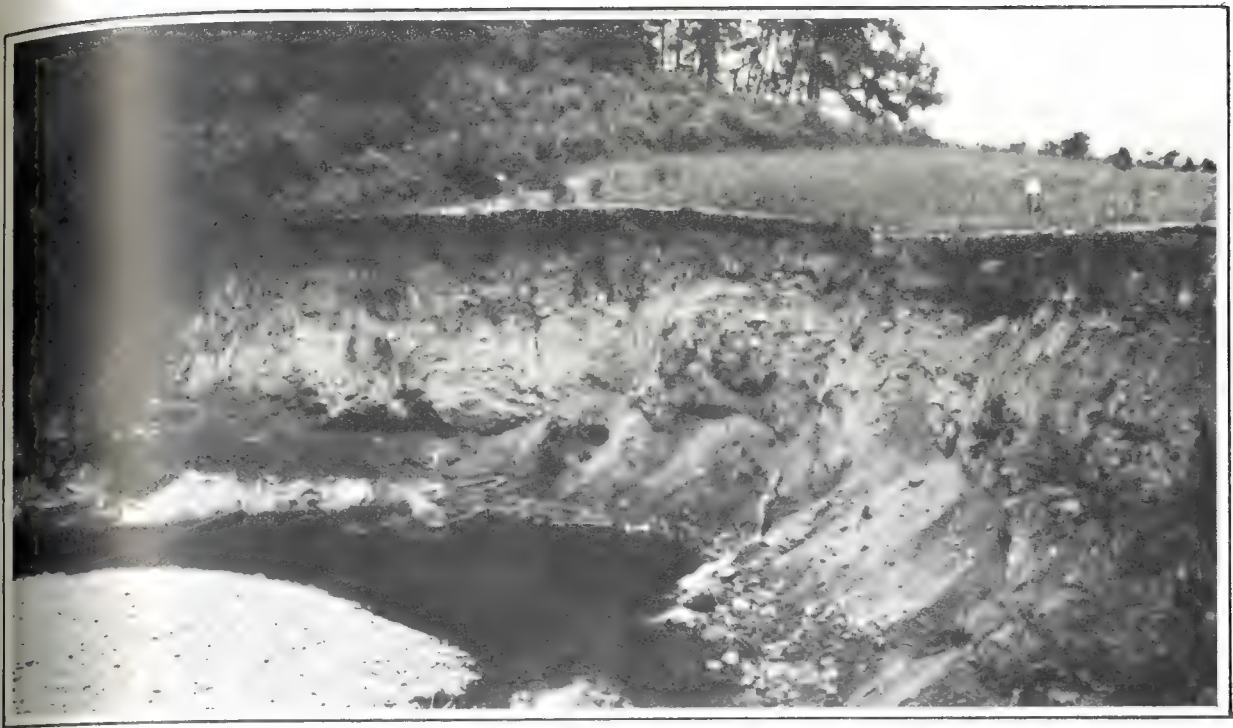
FIGURE 20 — PIGEON RIVER ATTACKS VALUABLE FARM LANDS

The August 30, 1940, flood cut almost halfway through the higher land which protects the valuable farm land shown on Figure 21. If this bank is not protected, future floods will probably cause the river to break through the narrow neck of high land and cut a new channel through the fertile bottoms shown on Figure 21.

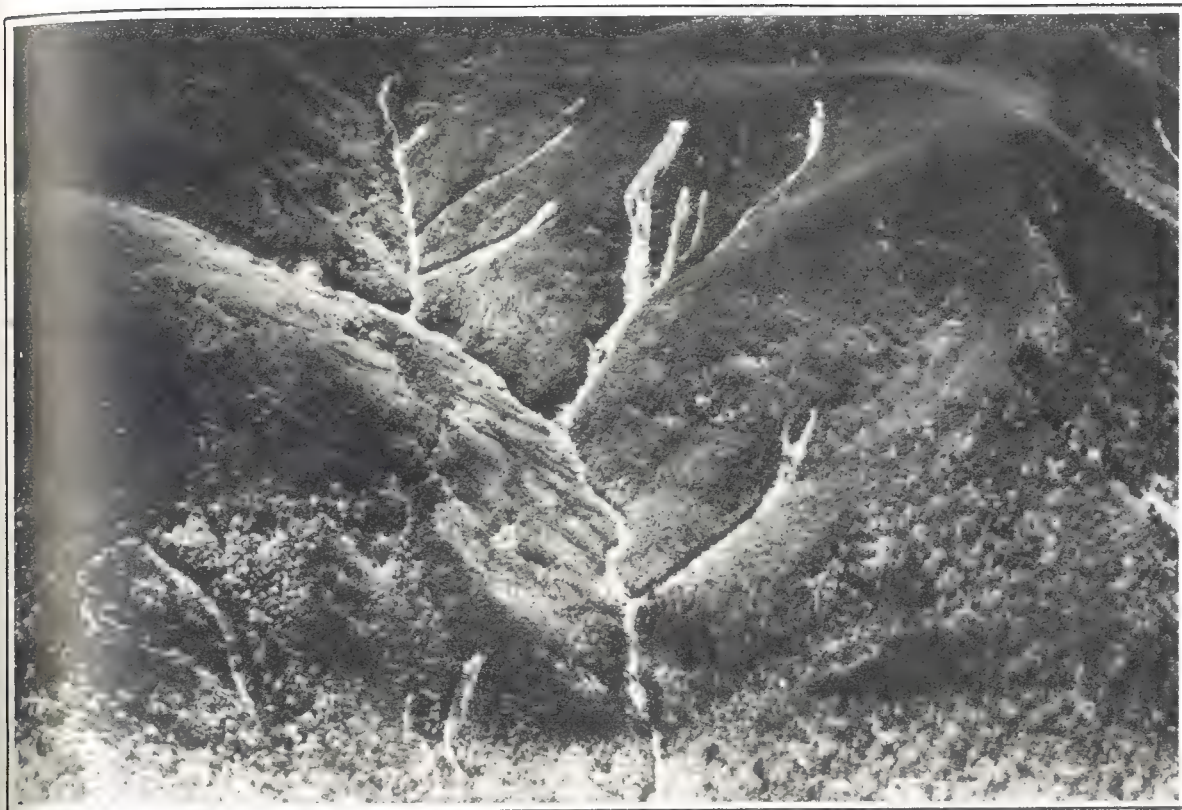
FIGURE 22 — MOUNTAIN VALLEY STRUCK BY HEAVY CONCENTRATED RAINFALL

Intense localized rainfall striking the mountain side erodes down to and sometimes into rock, carrying huge quantities of rocks and debris on to the lower valley lands causing destruction of crops and lands and often resulting in loss of life.

During the heavy rainfall of late August 1940, the headwaters of the West Fork of the Pigeon River above Canton were subjected to the attack of intense concentrated rainfall which resulted in the development of numerous mountain slide flows. Figure 22 is a picture of one of the mountain valleys in the upper Pigeon River watershed which was subjected to the excessively heavy rainfall in August 1940 and shows the resulting development of several slides. In this case, these started near the top of the mountain and followed the general drainage channels into the main draw. The soil mantle and inter-mixed rocks and boulders were scoured out down to the underlying rock.

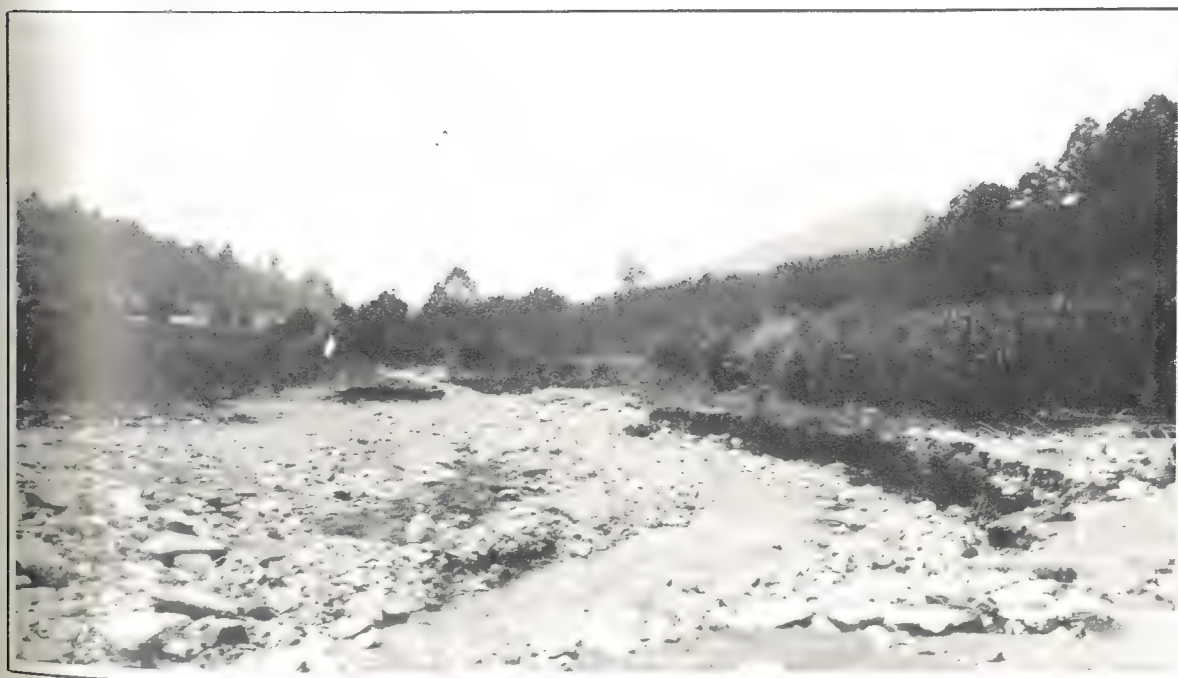
FIGURE 23 — FLAT CREEK BOTTOM LANDS DESTROYED JULY 16, 1941, FLOOD

Intense rainfall on the afternoon of July 16, 1941, resulted in a flood which brought down large masses of rocks and boulders depositing these on the narrow bottom lands. Creek banks eroded and new channels were scoured across cultivated bottoms.

The area having the heaviest rainfall is mountainous and about 75 percent forested. Along the creek are narrow cultivated bottoms. The rainfall was so intense that a large part of it ran off immediately. Flat Creek, ordinarily a small stream under five feet in width, rose rapidly until it was 200 feet wide and 10 feet deep. The velocity was high, resulting in scouring of the land. Fences were washed away, banks eroded, and in several places new channels were formed. Figure 23 is a view of the Flat Creek valley after the flood.
